# Watershed Restoration FACTSHEET: Dumont Oaks Stream Restoration and Stormwater Pond Retrofit

**Dumont Oaks Project Facts:**  
**Project Drainage Area:** 69 acres  
**Project Imperviousness:** 30%  
**Property Ownership:** Private

**Project Status:** Construction completed Spring 2004

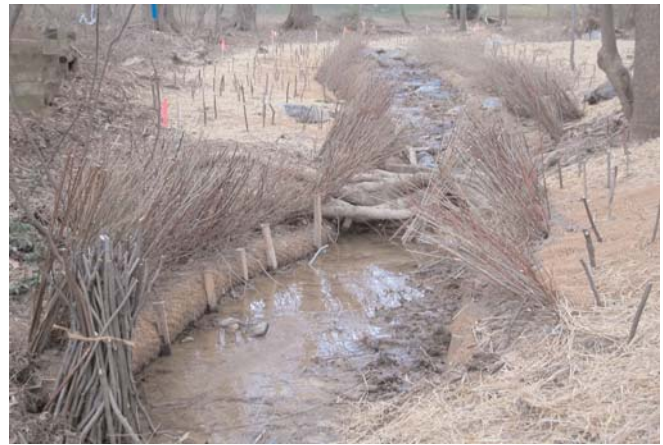
Restoration techniques included brush layering, live stakes and coir fiber toe protection

Stream banks were stabilized by installing rock or coir fiber logs <sup>9</sup> at the toe of the stream bank slope. The slopes were then graded

back to create terraces, where native plants were added to increase soil stability. Bio-engineering methods such as brush layering <sup>9</sup> and live staking <sup>9</sup> were also used to add vegetative stabilization above the coir logs. In some places, the stream invert, or lowest channel point, was raised to allow the previously entrenched stream access to the flood plain, which allows stormwater flow energy to dissipate.

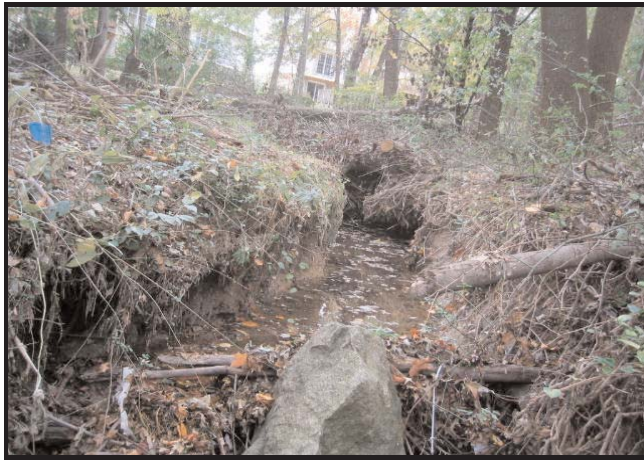
Over time, the stream channel down-cut and became entrenched and eroded, undercutting trees and causing damage to private property. Headcuts formed and migrated

Pre-restoration conditions: severely downcut, entrenched and eroded stream channel

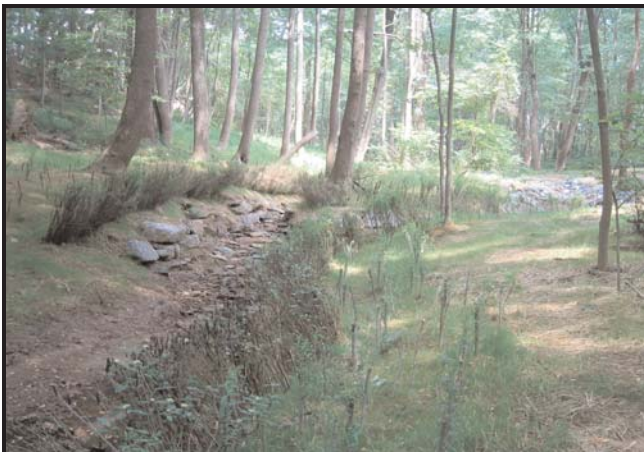
Completed stream restoration, Spring 2004

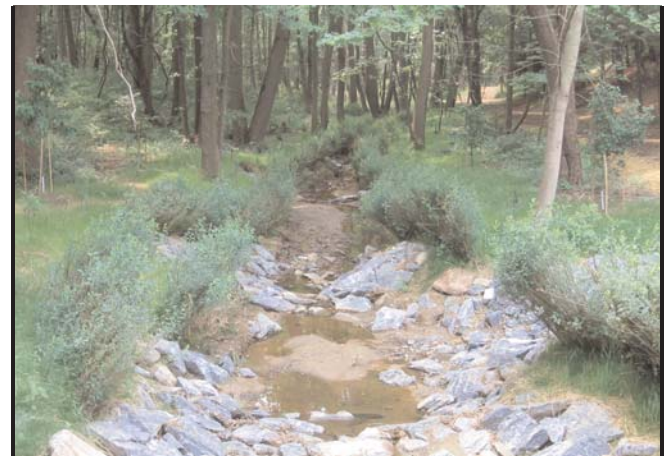
A step pool, constructed at a stormdrain outfall, allows erosive stormwater energy to dissipate, while rocks also function as "riffle" grade control.

Damaged storm drain outfalls were repaired, and step

pools <sup>9</sup> were constructed that allow stormwater to lose erosive energy. Vernal pools were created to catch overland flow and stormwater. The vernal pools quickly established balanced aquatic communities, which added additional habitat benefits, including natural mosquito control.
